VT No. 32-2152

SERVICE BULLETIN

MILWAUKEE-EIGHT ENGINE - CRANKSHAFT POSITION SENSOR

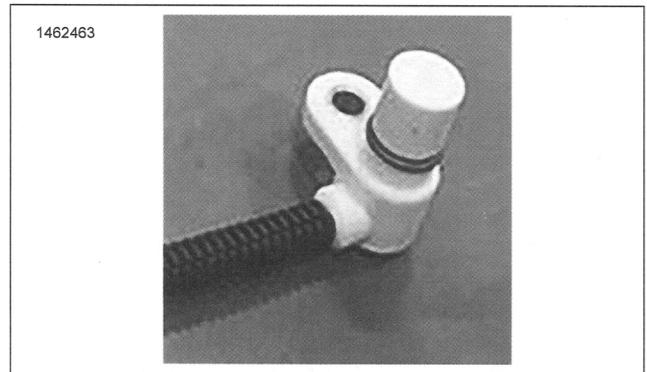
Figure 1. New CKP Sensor

- See Figure 1. The CKP Sensor body is white in color.
- See Figure 2. Some discoloration (1) and sensor body doming (2) may be noted over time and occurs with engine heat cycles. This is not grounds for replacement or signs of a sensor defect.
- If a sensor is suspected of being defective, follow the diagnostic steps outlined within the Electrical Diagnostic Manual (EDM) for the appropriate model and model year of the vehicle being repaired.

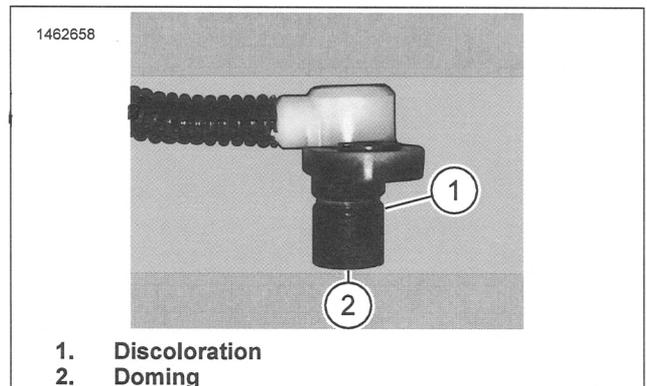
Figure 2. Heat Cycled CKP Sensor

1. Discoloration
2. Doming
