49-0946

NECESSARY FLYWHEEL CLEARANCE TO REPLACEMENT LEFT CASE ONLY

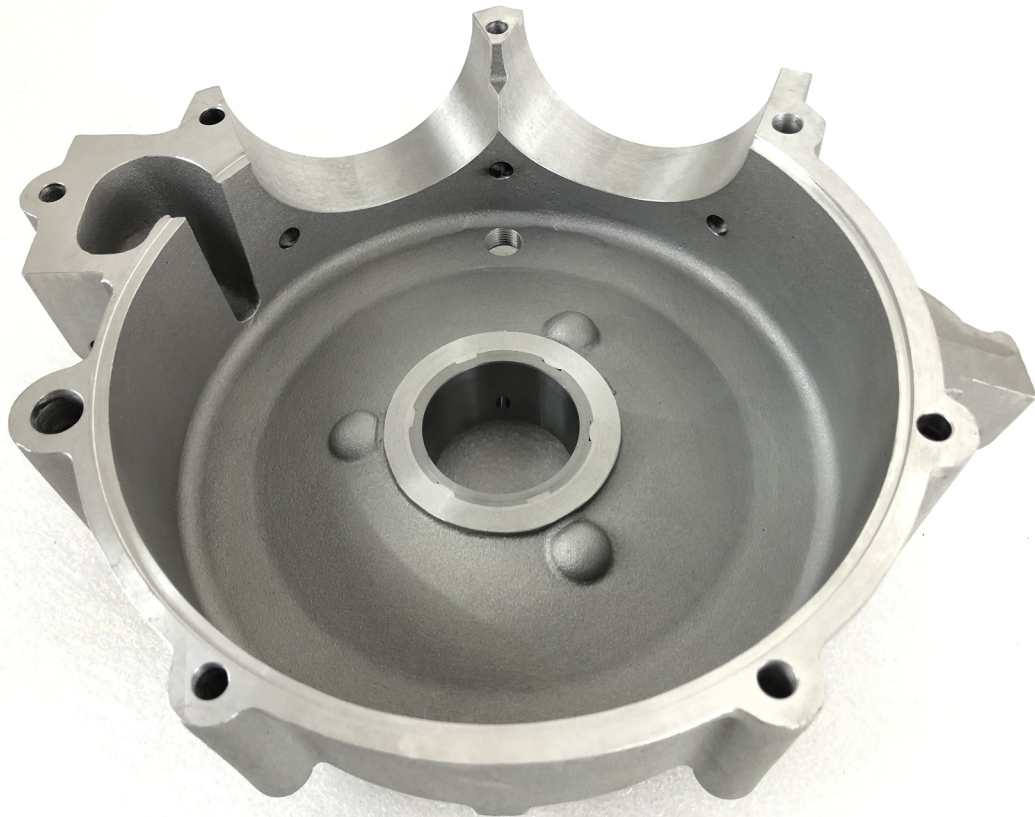
THE DEPTH OF THE FLYWHEEL SIDE MAY NEED TO BE INCREASED. MEASUREMENT FROM CENTER CRANKCASE JOINT SEEM DOWNWARD SHOULD REACH A DEPTH OF 2.400. AREA NEAREST THE OIL SCRAPER NEEDS THE MOST MATERIAL REMOVED.
