VT No. 18-3269 INSTALLATION INSTRUCTIONS

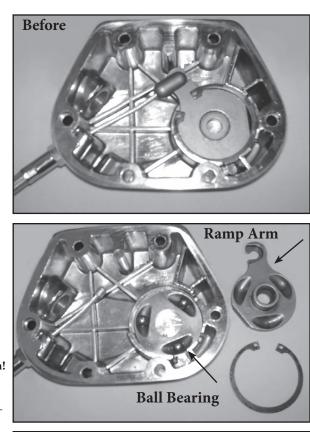
• Install the Easy Pull Clutch Assist on the ramp piece as illustrated on the right. Be sure that the bolt is tight, **10 to 12 ft lbs.**

• CLUTCH ADJUSTMENT: Stand the machine upright and remove the clutch inspection cover. Disconnect the cable from the hand lever. Loosen the nut on the adjustment screw. Using an allen wrench, turn the adjustment screw inwards (clockwise) until all the play is removed. Now back the screw out ¾ of a turn. Re-tighten the locknut while holding the screw in place. Re-attach the clutch cable and replace the inspection cover. Remove excess cable play with the cable adjuster. If excess cable play cannot be adjusted out per the adjuster, install the supplied upper spacer on the upper end of the cable near the Lever Perch to take up the difference (see illustration).
